## Test Report

NBF26-0015899-01

Sample Name: MP-UVC-48LC-PLUS

Removal rate of microorganism (*Bacillus subtilis* spore) at the startup of operating life.

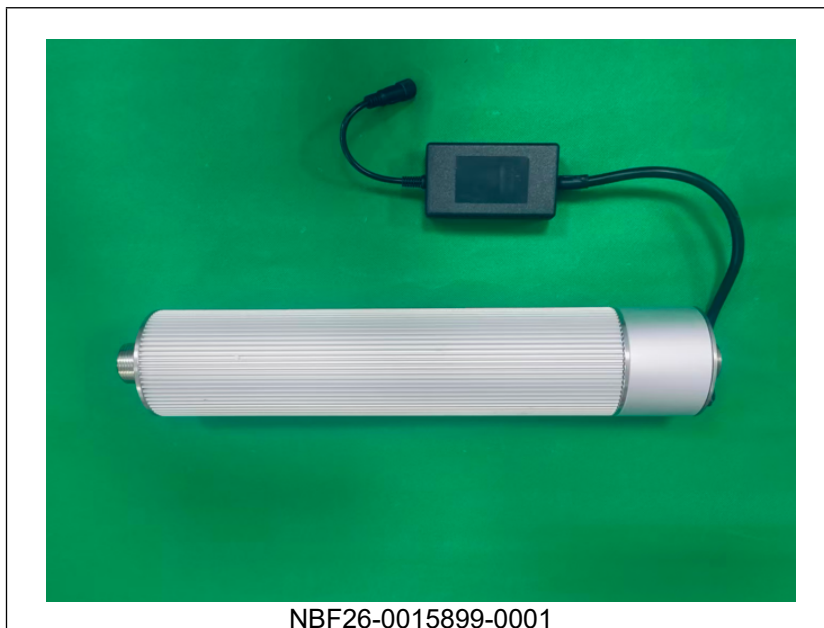
NBF26-0015899-0001

Sample photo:
